**Site and Reach Assessment  
Puyallup River  
at SR 162 Bridge 162/006**

**Work Order XL2760**

**Rob Schanz, Hydrologist  
WSDOT Environmental Services  
Hydrology Program**

**October 2014**

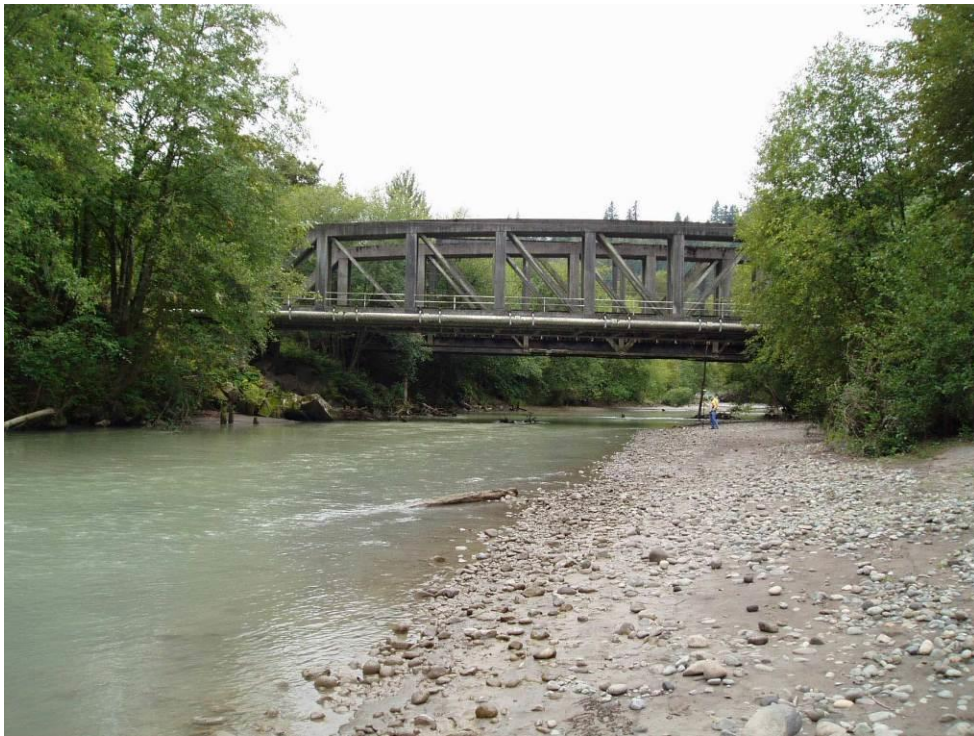
**Figure 4. Photo of Bridge 162/006 from Downstream**

Bridge 162/006 was built in 1934 as a reinforced concrete truss structure that spans the Puyallup River (Figure 4) (WSDOT, 2007). It is supported on each bank by piers on spread footings. The bridge consists of a 170-foot main span with 20-foot approaches on each bank. Piers 2 and 3 support the main span, and are placed at the edge of the active channel on each bank.

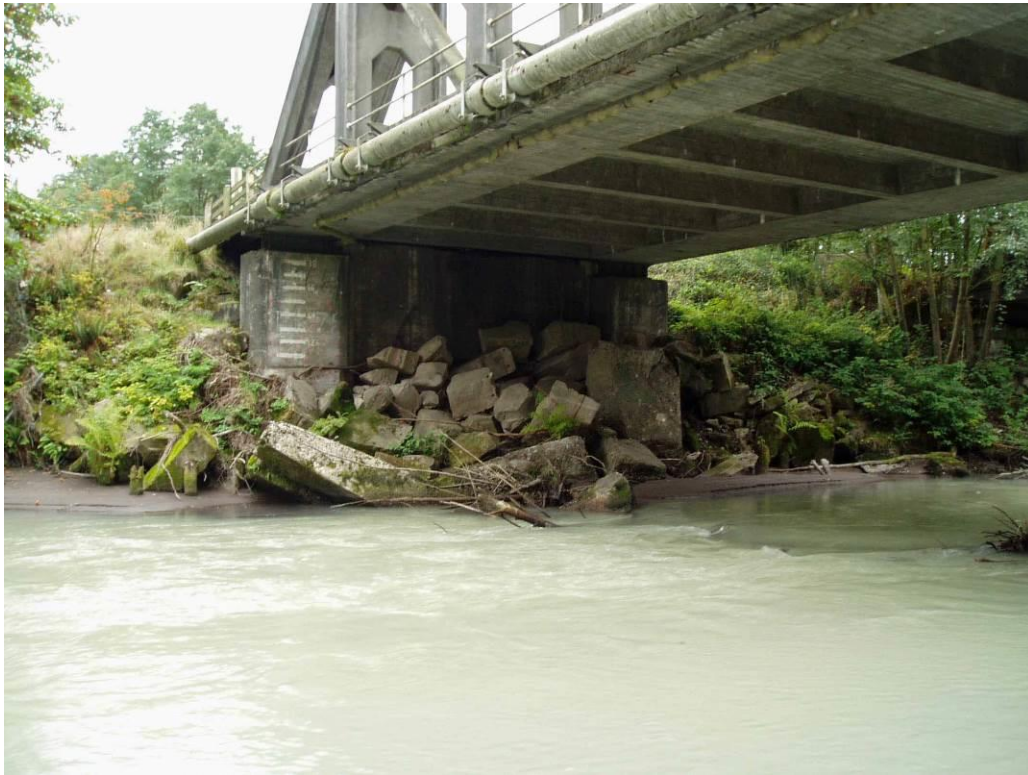
**Figure 6. Photo of Armor around the Base of Pier 3**

WSDOT Bridge Inspection Reports from 1995 through 2005 noted that the west abutment cap was undermined and H-piles were exposed up to 16 inches (WSDOT, 2007). The original 1934 bridge plans indicate scour concentrated next to the right bank abutment pier (Pier 3). Large chunks of 3- to 6-foot concrete rubble cover the base of Pier 3 to protect against scour (Figure 6). On the left bank Pier 2 is buried in a sandy slope, and shows no sign of scour.

**Minimizing scour risks and impacts of piers on channel habitat:** The proposed design avoids placing piers in the active channel to reduce the risk of scour and avoid impacts to ESA-listed fish. Piers foundations within Pierce County's Channel Migration Hazard zone will be designed to anticipate potential channel scour.

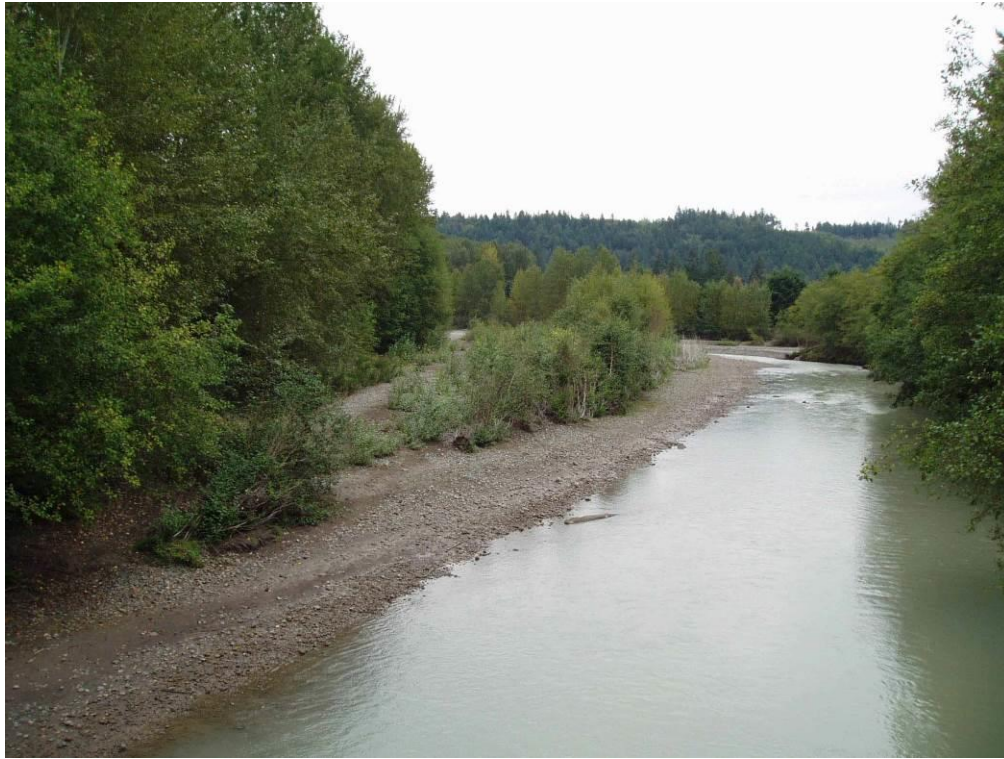
**Figure 7. Photo of Sediment Deposits Downstream from Bridge 162/006**

Extensive sediment deposition begins downstream of the bridge, and is probably related to the backwater effects of sediment deposited at the Carbon River confluence (Figures 7 and 8). A sand bar begins at the base of the left bank under the bridge, and becomes steadily wider and coarser downstream. About 200 feet below the bridge this bar consists of gravel and cobble embedded in fine sand, and slopes upward onto a gravel and cobble berm with a high flow channel along the back edge (at the toe of the riverbank). The width of the bar exposed in the late summer increases from about 30-feet just below Bridge 162/006 to over 80-feet about 200-feet downstream.
